November 1943 as
Advance Restricted Report 3K10

**FLIGHT TESTS OF THERMAL ICE-PREVENTION EQUIPMENT
ON A LOCKHEED 12A AIRPLANE**

By Richard Scherrer

Ames Aeronautical Laboratory
Moffett Field, California

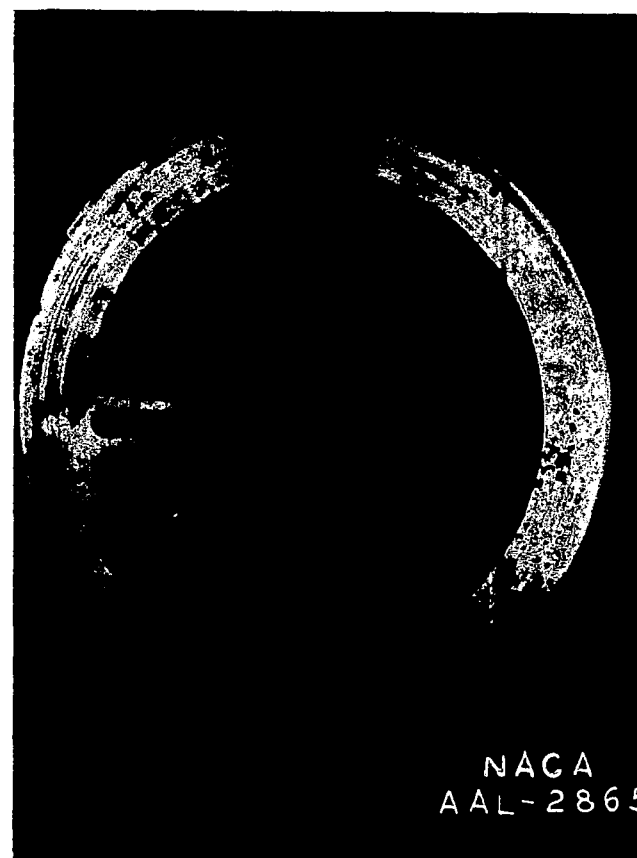
(a) Side view

(b) End view

Figure 2.- The cast-aluminum heat exchanger as used in the ice-prevention system of the Lockheed 13A airplane. NACA heat exchanger Design No. 22.

The heated air for the thermal ice-prevention equipment was obtained from cross-flow heat exchangers in the exhaust system of each engine. The heat exchangers are shown in figure 2 and were designed and fabricated by the NACA from Alcoa 122 aluminum alloy. The notch in the external fins shown in figure 2 provided for a baffle separating the incoming and outgoing air streams. The heat exchanger as shown weighed 25 pounds. This heat exchanger, design No. 22 in the series being tested at AAL, was designed to transfer 100,000 Btu per hour with an air-flow rate of 1600 pounds per hour and a flight speed of 150 miles per hour in the Lockheed 12A airplane.
